THE DAMAGE TO STRUCTURES CAUSED BY THE SECOND MIYAKOJIMA TYPHOON

ISHIZAKI, Hatsuo ...[et al]. THE DAMAGE TO STRUCTURES CAUSED BY THE SECOND
MIYAKOJIMA TYPHOON. Bulletin of the Disaster Prevention Research Institute 1968, 18(1):
1-14

by Hatsuo ISHIZAKI, Junji KATSURA and Tatsuo MUROTA

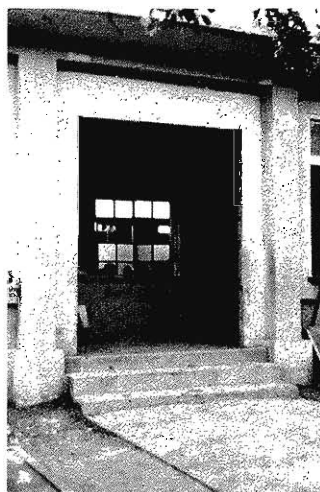
Reinforced concrete buildings. Reinforced concrete buildings of schools, offices, dwellings were only partly damaged; mostly broken doors and windows. (Photo. 3)

Photo. 3 Damage to reinforced concrete buildings; a broken door.

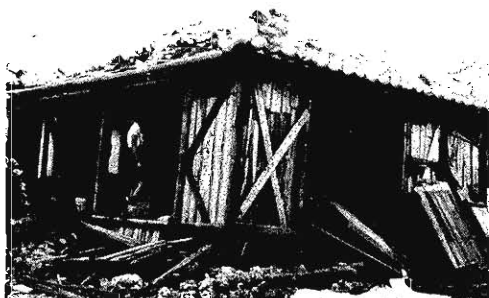
Photo. 4 Damage to wooden buildings with clay-tile roofings ;

(a) wreckage of openings, (b), (c) removal of tiles from ridges and corners, (d) removal of tiles from the eave, (e) total destruction of a school building. (by courtesy of the Miyako Bureau of Local Administration =(a), (b), Hirara City Hall= (d), and The Okinawa Times=(e)).

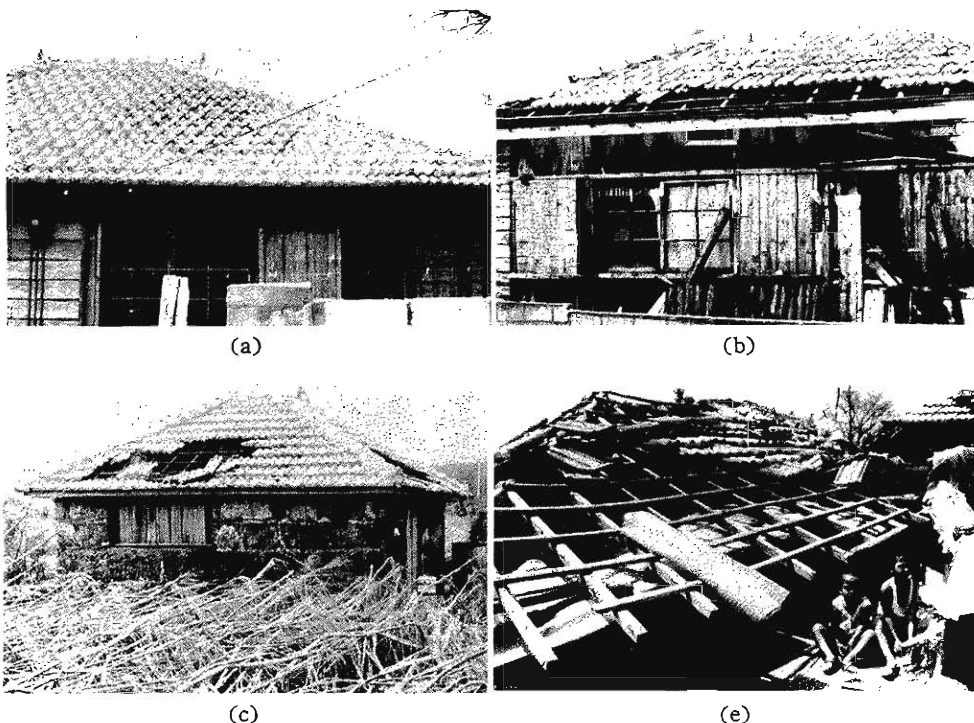
Photo. 5 Damage to wooden building with cement-tile roofing :

(a) lifting of tiles from a leeward roof, (b) removal of tiles from eave, (c) (d) removal of tiles from leeward roofs, (e) total destruction of a house. (by courtesy of Hirara City Hall=(b), the Miyako Bureau of Local Administration = (c), the U.S. Civil Administration of the Ryukyus = (d) and The Okinawa Times = (e)).

- i) broken doors and windows
- ii) lifting of tiles from leeward roofs
- iii) removal of tiles from leeward roofs, eaves or verges
- iv) total destruction

The lifting and removal of tiles are closely related with damage to openings in the walls.
